# Performance Oil Catch Can Kit Part Number: 860-003

Toyota 2022-2024 Tundra 3.4L Turbo Toyota 2023-2024 Sequoia 3.4L Turbo

## **Installation Instructions**

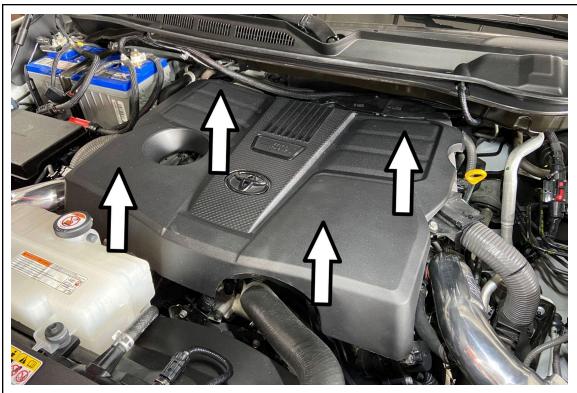
2. Lift and remove the engine cover from the vehicle.

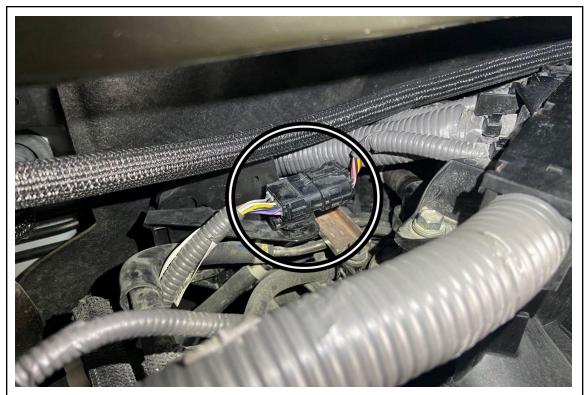
3. Unclip the electrical harness from the mount.

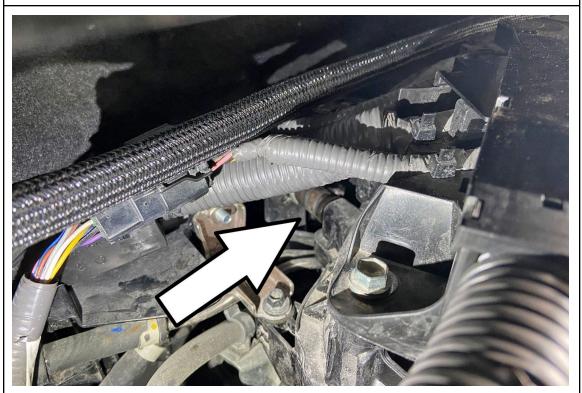
4. Depress the hose clamp and disconnect the PCV hose from the engine.

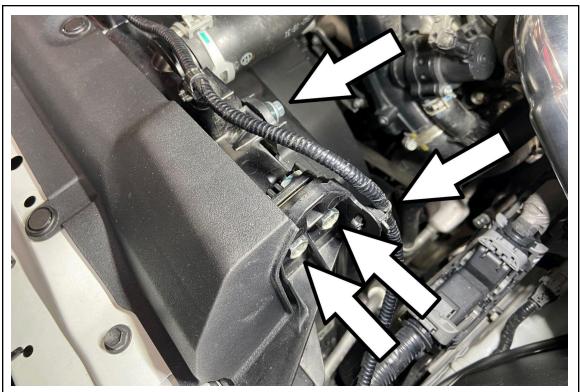
5. Unclip the electrical harness at the radiator shroud. Remove the two 12mm head bolts and the one 10mm head bolt securing the radiator shroud at the area indicated in the image above.

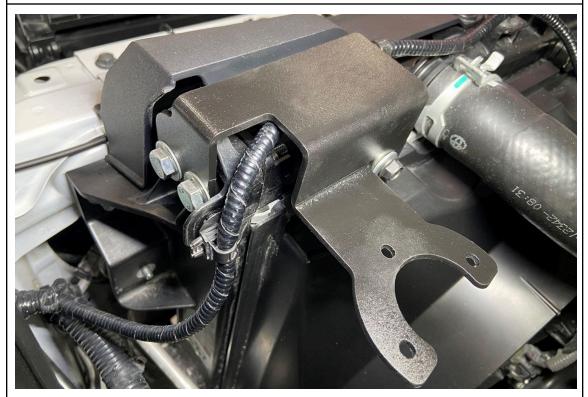
6. Secure the HPS oil catch can bracket onto the radiator shroud using the two provided M8 x 45mm bolts, two M8 washers, M6 x 30mm bolt, and M6 washer.

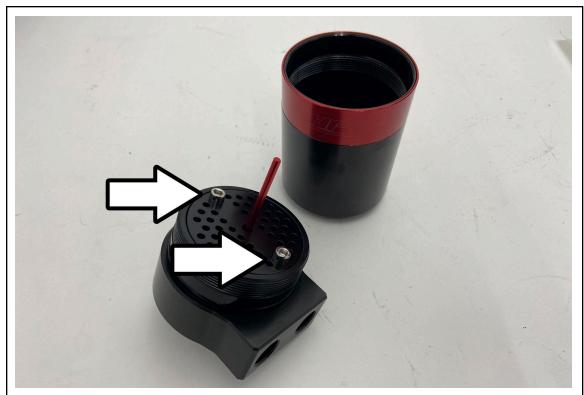
7. Unscrew the top of the HPS oil catch can and check that the Allen bolts are tight.

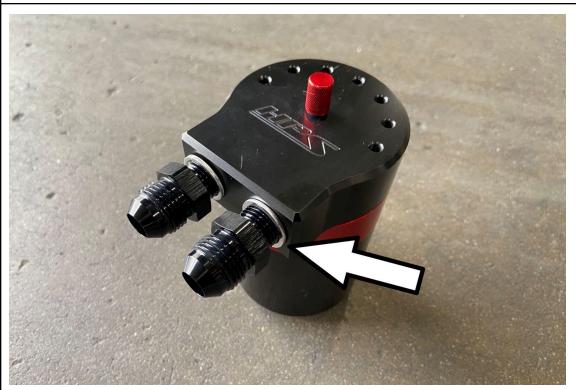
8. Secure the two -8 AN to M16 x 1.5 fittings along with the provided crush washers onto the HPS oil catch can.

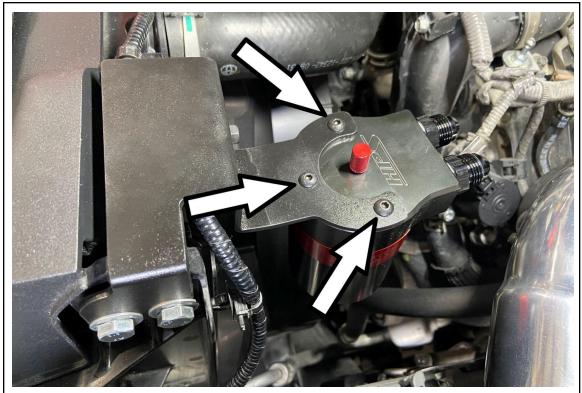
9. Position the HPS oil catch can and secure it to the bracket using the three provided M5 Allen bolts.

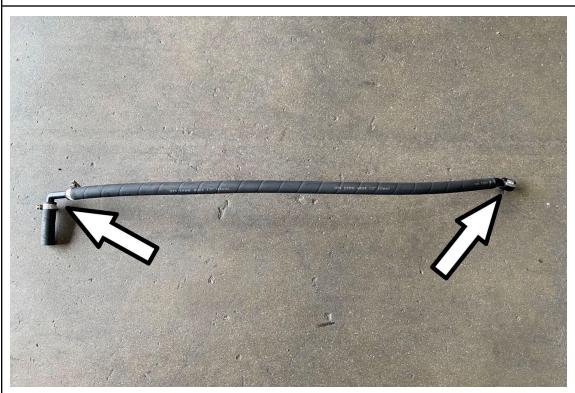
10. Push the provided 90 degree barb fitting into one of the long AN hose and secure it using an EMSC clamp. Push the short AN hose to the other end of the 90 degree barb and secure it using another EMSC clamp. On the other end of the long AN hose, push on the provided 30 degree -8 AN hose end fitting.

**NOTE:** Possible trimming will be needed for a proper fitment during the install.

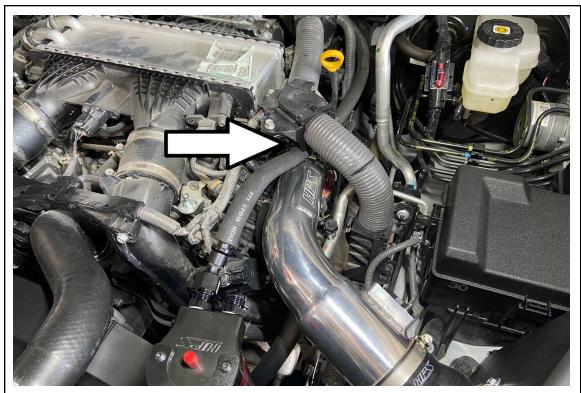
11. Attach the 30 degree hose end to the oil catch can. Run the hose underneath the engine harness and to the back of the engine.

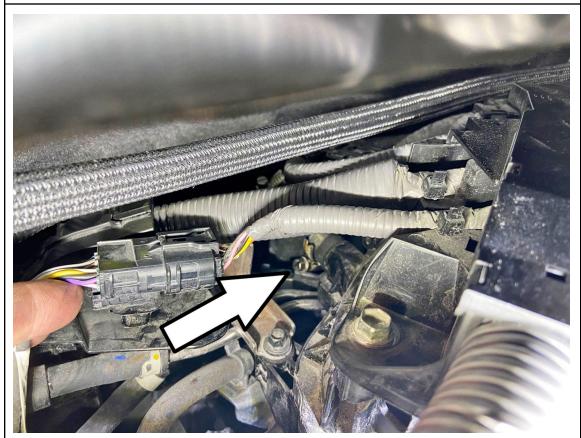
12. Secure the other end of the hose to the engine (where the PCV hose was disconnected in step 4) with the provided EMSC clamp.

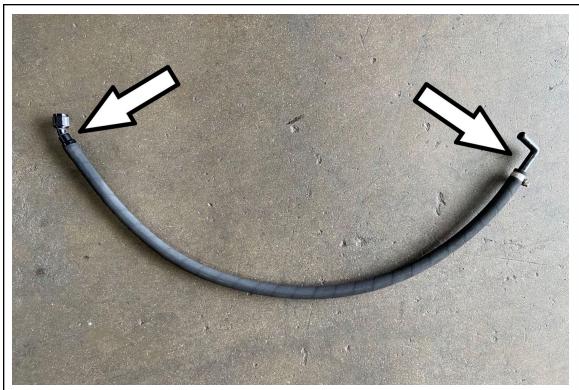
13. Push the second provided 90 degree barb fitting into one end of the second long AN hose and secure it using an EMSC clamp. On the other end of the hose, push on the second 30 degree -8 AN hose end fitting.

**NOTE:** Possible trimming will be needed for a proper fitment during the install.

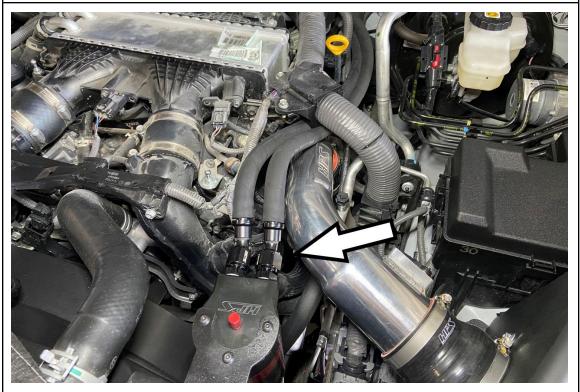
14. Attach the 30 degree hose end to the oil catch can.

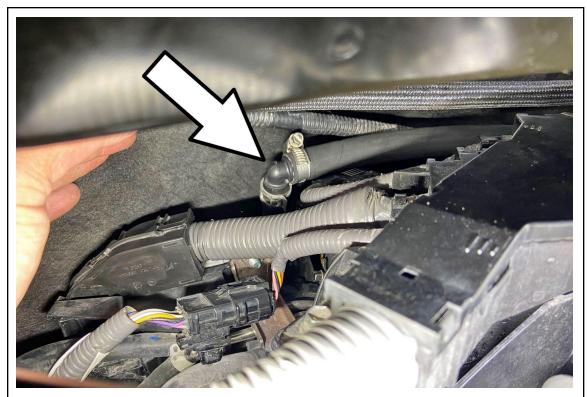
15. Run the hose underneath the engine harness. Push the barb fitting into the factory PCV hose and secure it using the factory clamp.

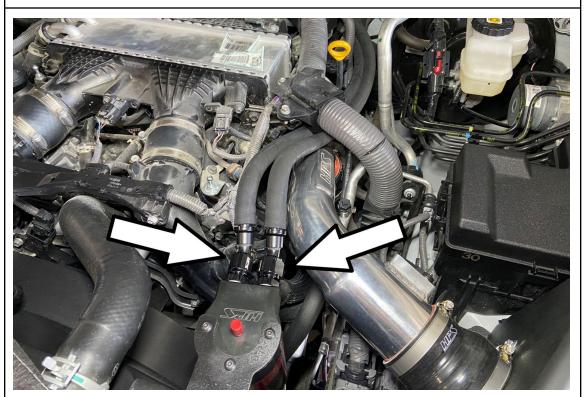
16. Rotate the AN fittings into position for proper clearance around neighboring engine bay components.

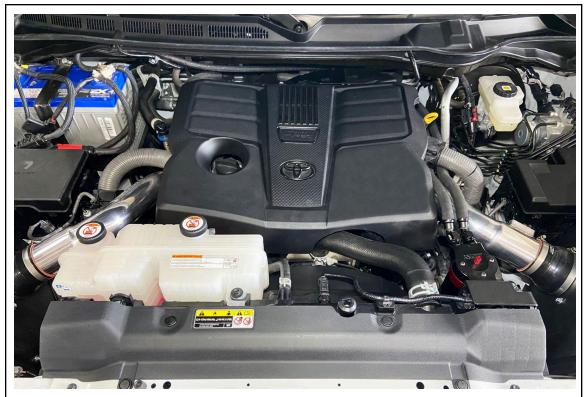
17. Reinstall the engine cover onto the vehicle.
