# CLUTCHTECH

## TSB-177 CAUTION!

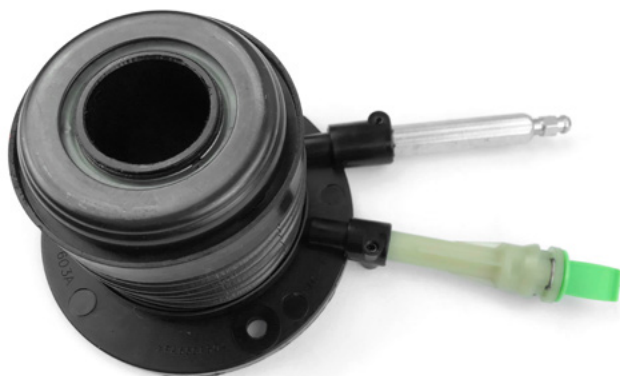
The hex tube that runs from the CSC to the bleeder nipple does not rotate. If too much rotating force is applied to the tube to tighten or loosen the bleeder nipple, the hex tube can shear off inside of the bellhousing.

BLEEDER TUBE DOES NOT ROTATE

It is recommended to loosen the bleed nipple initially before installing the CSC so that a second ring spanner can be used to support the hex tube and avoid excess force being applied to the CSC body.

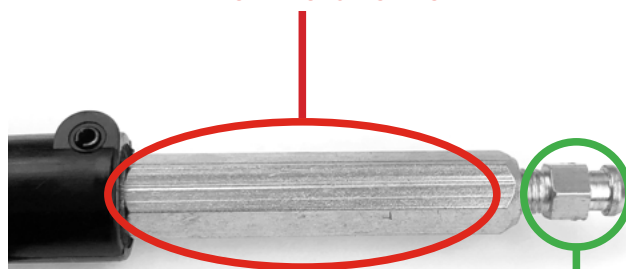
BLEEDER NIPPLE ROTATES
